East Yellow Creek
Recreational Use Attainability Analysis

July 2005

Prepared by:
MEC WATER RESOURCES, INC.
1000 North College Avenue, Suite 4
Columbia, Missouri 65201

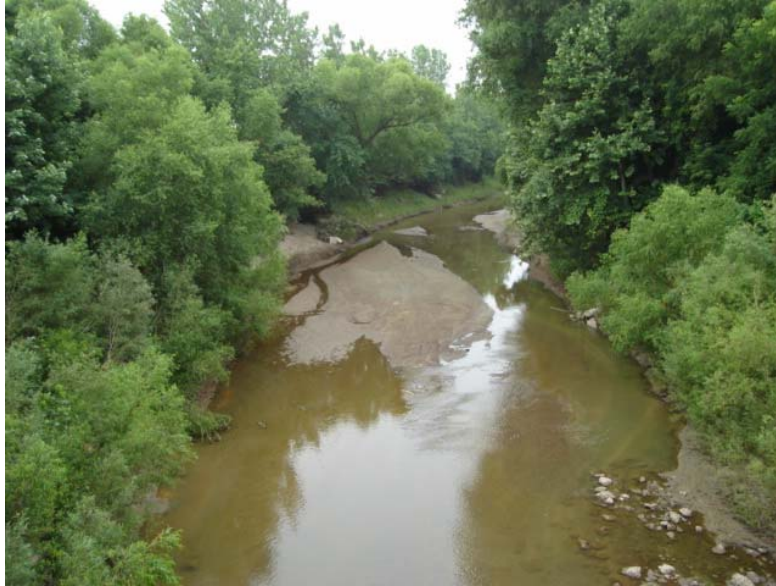
Figure 5. East Yellow Creek Site 2 Downstream View

The stream banks near the road are steeply sloping and are covered with low-growing brush and rocks (Figure 4). Riparian areas are vegetated by the upland deciduous forest complex and row crop agriculture. The stream channel was observed to be mostly sand with some cobble and gravel (Figure 5).

Mean depth along a 900 ft. assessment reach was 0.38 ft. as determined from 11 transects (Appendix B). The maximum depth observed at this location was .91 ft. in a small pool downstream of the road access. Flow was measured as 8.55 cfs.

MEC staff concludes that WBCR is neither an existing or an attainable use at this site based on absence of observed recreational uses, low flow shallow conditions and difficult stream access imposed by steeply sloping banks.

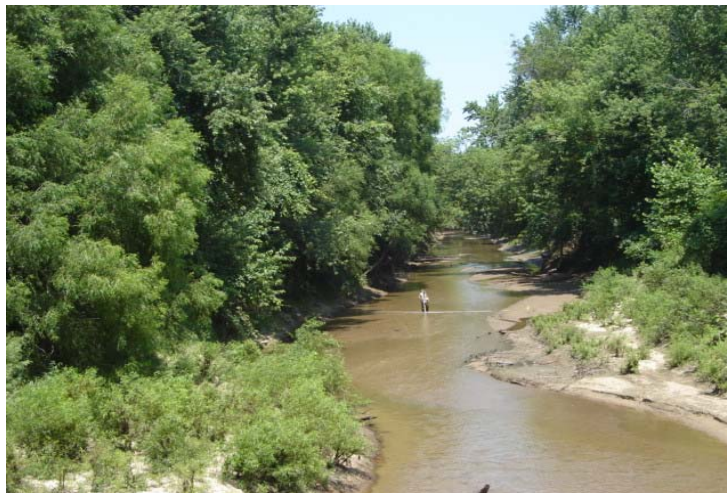
Figure 6. East Yellow Creek Site 3 Downstream View

The riparian area is generally wider at Site 3 than that at Sites 1 or 2 and consists of larger trees, thick brush, and some grassy areas (Figure 6). The stream banks at Site 3 are somewhat steep and covered with rocks, brush, and downed trees (Figure 7). Stream substrate consisted of mostly sand with some mud and clay.

Mean depth along a 700 ft. assessment reach was 0.57 feet as determined from 11 transects (Appendix B). The maximum depth observed at this location was 2.74 feet in a pool downstream of the road access. Measured streamflow was 11.21 cfs.

MEC staff concludes that WBCR is neither an existing nor an attainable use at this site based on the low flow shallow conditions and the lack of observed WBCR uses.

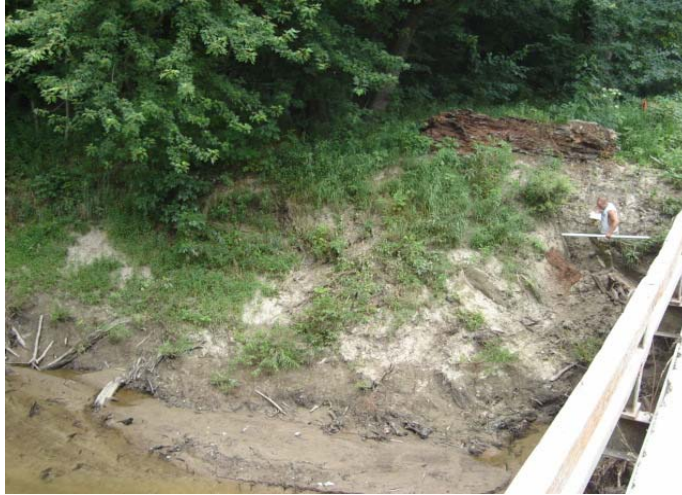
Figure 8. East Yellow Creek Site 4 Right Bank

The stream banks near the crossing at Road 208 are steeply sloping and lightly vegetated (Figure 8). Riparian areas are vegetated by upland deciduous forest and row crop agriculture. The stream channel was observed to be mostly sand with some cobble and gravel. A large pool was present downstream from the bridge and was likely due to the logjam that stretched across the stream beneath the bridge (Figures 9 and 10).

Mean depth along a 960 ft. assessment reach was 0.55 ft. as determined from 11 transects (Appendix B). The maximum depth observed at this location was 1.66 feet. Measured streamflow was 11.21 cfs.

MEC staff concludes that WBCR is neither an existing nor an attainable use at this site based on the low flow shallow conditions, steep slopes, and the lack of observed WBCR uses.
